# Late of Utah DEPARTMENT OF NATURAL RESOURCES Division of Oil, Gas & Mining

## **Inspection Report**

Mine Name: Cameron #1 and TME AR Lecy	<b>Permit number:</b> \$0470036 and \$0470088
Operator Name: TME Asphalt Ridge	<b>Inspection Date:</b> September 11, 2007
	Time: About 11:30 AM to 12:30
	PM
Inspector(s): Paul Baker

# S0470036 and S0470088, Cameron #1 and TME AR Lecy Mines, TME Asphalt Ridge

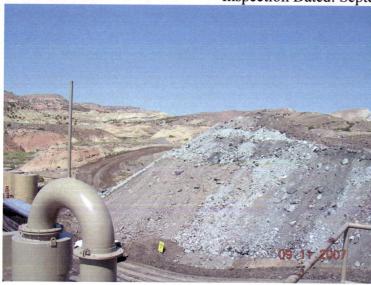
The operator has been actively mining the new TME AR Lecy Mine. Topsoil was windrowed around the edges of the pit (across the middle of Photo 2), and overburden from this mine was placed in the Cameron #1 pit (Photo 1).

Photo 1. This is overburden from the TME AR Lecy Mine.

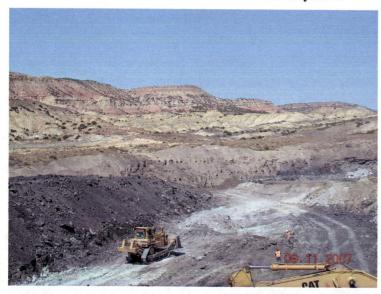
I expected to see ground water in the pit (Photos 2 and 5), but there was none. Perhaps the water I have previously seen in this area is from a shallow source and has dried up during the summer.

Photo 2. This is the TME AR Lecy Mine. Soil is stockpiled near the edge of the pit as shown across the center of the photo.

The soil around the edge of the pit should be seeded this fall.

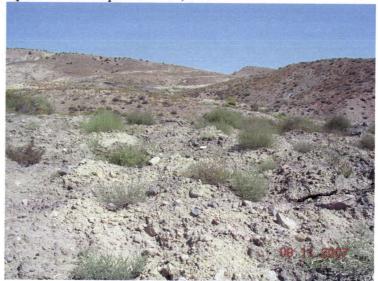
The area that was regraded and seeded in the fall of 2006 is shown in Photos 3 and 4. Most of the vegetation is Russian thistle, but there is some fourwing saltbush, yellow sweet clover, and grass. Perennial cover is not yet what it needs to be, but I was encouraged to see this much growth. I did not look closely at the area seeded in the fall of 2005.

Photo 3. This is the area that was reclaimed in the fall of 2006. Most of the plants are Russian thistle, but there is some fourwing saltbush, yellow sweet clover, and grass.

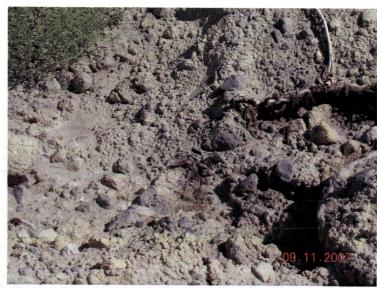
Photo 4. Some of the grass in the reclaimed area.

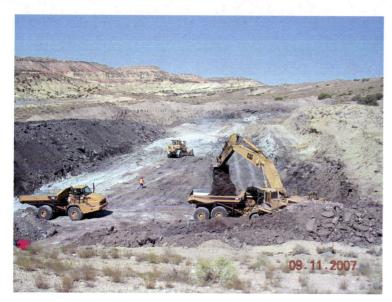
Photo 5. An overview of operations in the TWM AR Lecy pit.

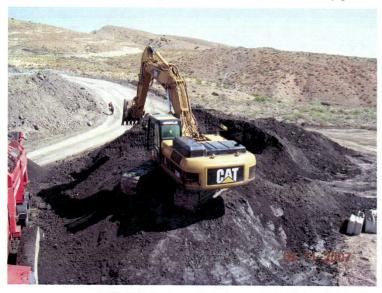
Photo 6. Tar sand is stockpiled and fed through a screen to the processing unit.

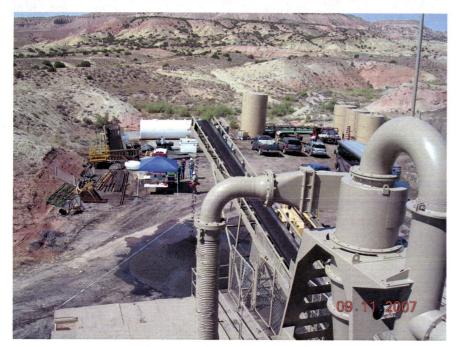
Some water was flowing from the processed sand, and there did not appear to be any effort to contain or control this water. The operator told me in an October 1 e mail that the area has been graded so water returns to a recovery point. The water is restricted by a layer of asphalt from getting into ground water.

Photo 9. This is the main unit of the processing equipment. Note the sand coming off the conveyor and the liquid around the sand pile.
